Analysis: Omnilert Gun Detection Test Performed 08/31/2022

This test was performed to evaluate the detection capabilities of the Omnilert Gun Detection solution in conjunction with selected surveillance cameras at Felicita and the District Office.

We began testing at Felicita at 6am on 8/31/22, waited until full daylight was available at 6:20, then met at the District Office to complete our testing.

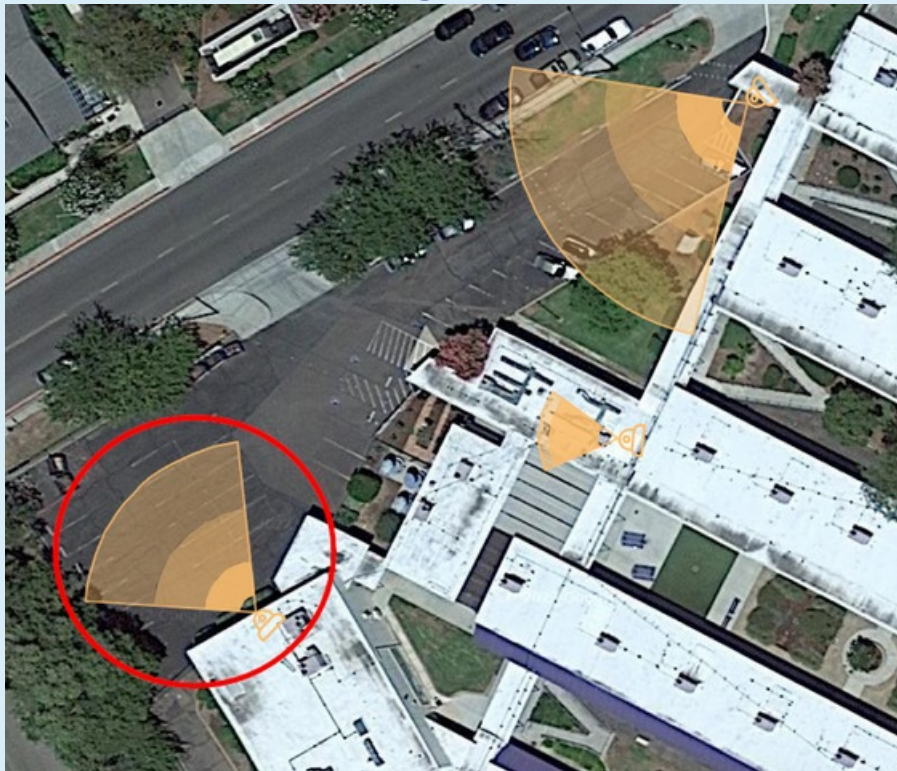
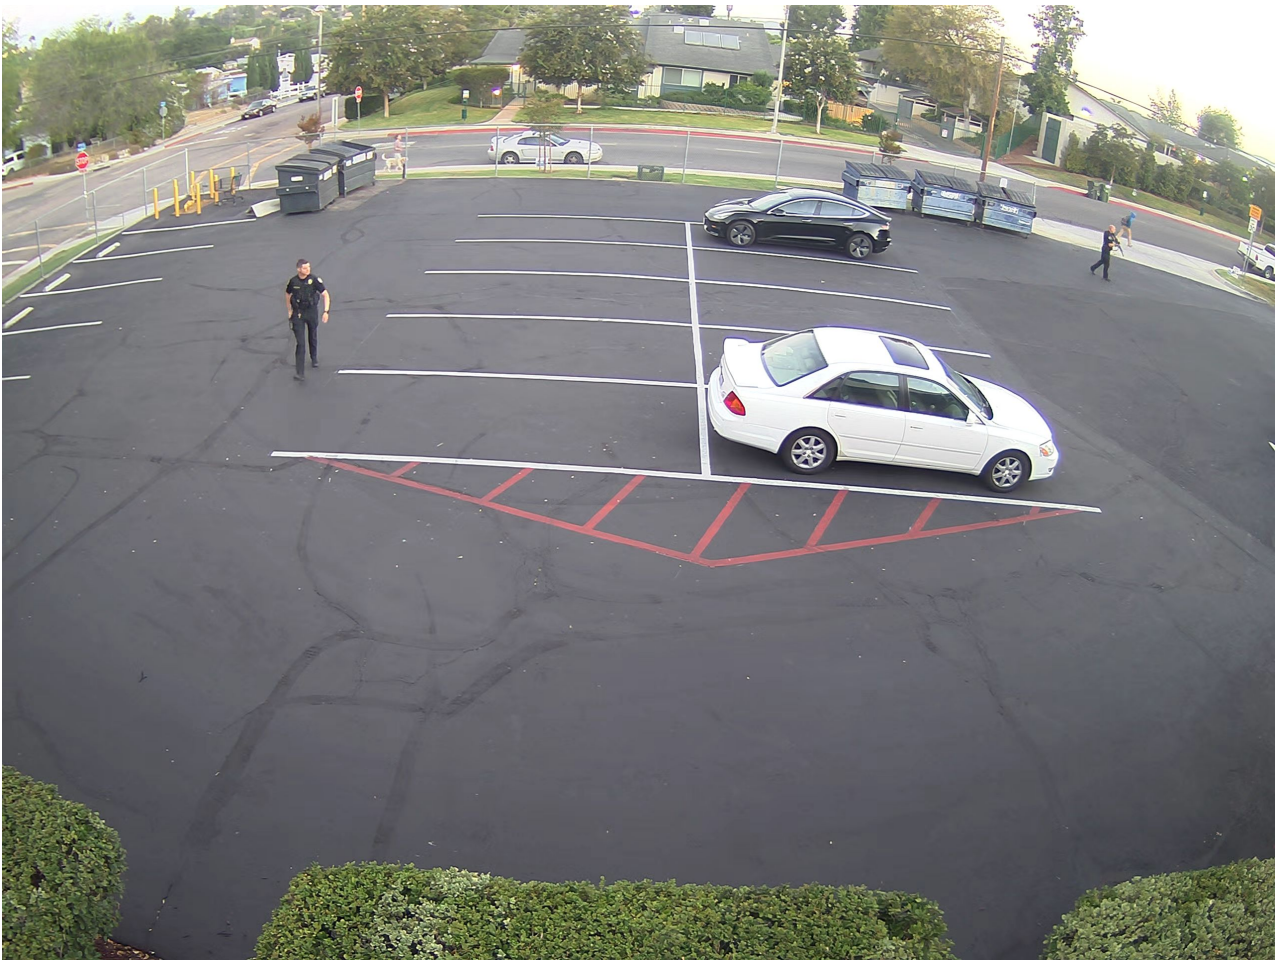
Felicita parking lot cam 1

We got no detections from this camera. Below is a clip that I would like to review and understand how no weapons were detected. The officer at the top right with the rifle is at ~20ppf range, so not getting a detection there is understandable. However, the officer headed towards the bottom of frame pulls his weapon and holds it up well within advertised detection range. Could it be the object detection bounding box added by the camera?

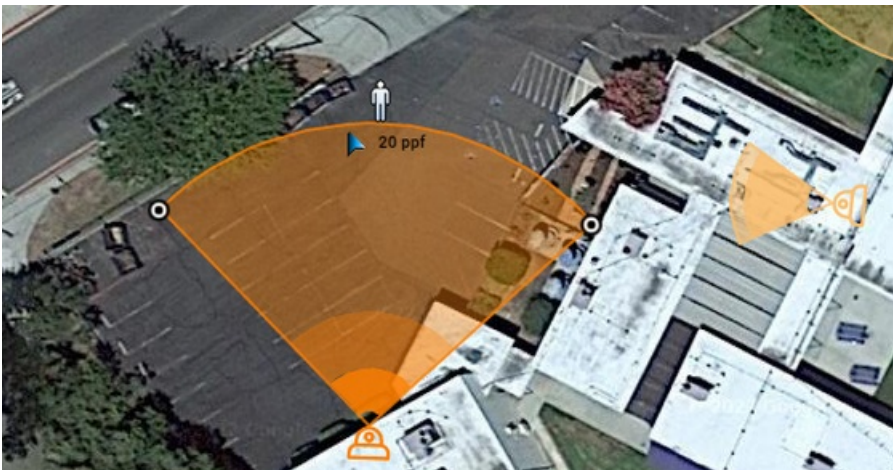
And the ppf approximation from IPVM:

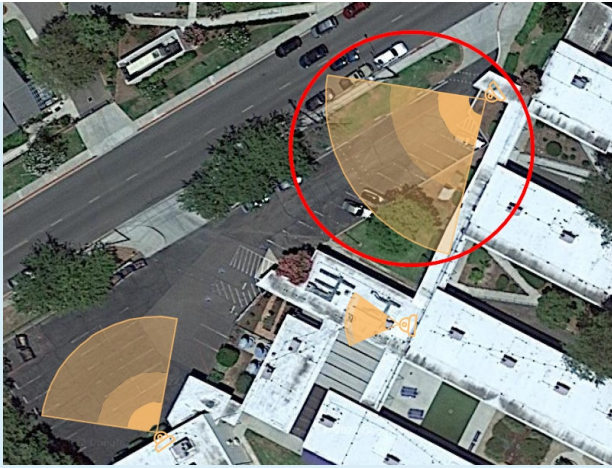
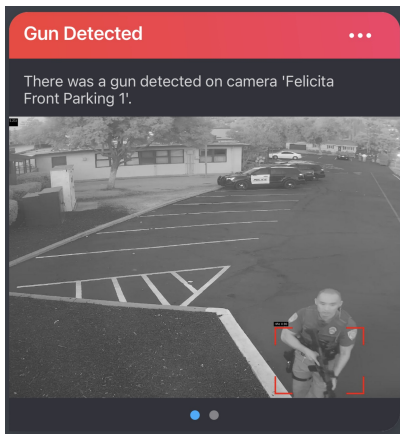
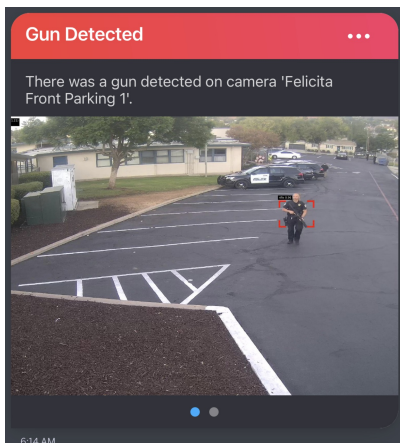
Felicita parking cam 2

We got two detections from this camera once we were out of low-light conditions:

The officer was walking around with a rifle for a significant amount of time, and we only got these two detections, so that's a concern.

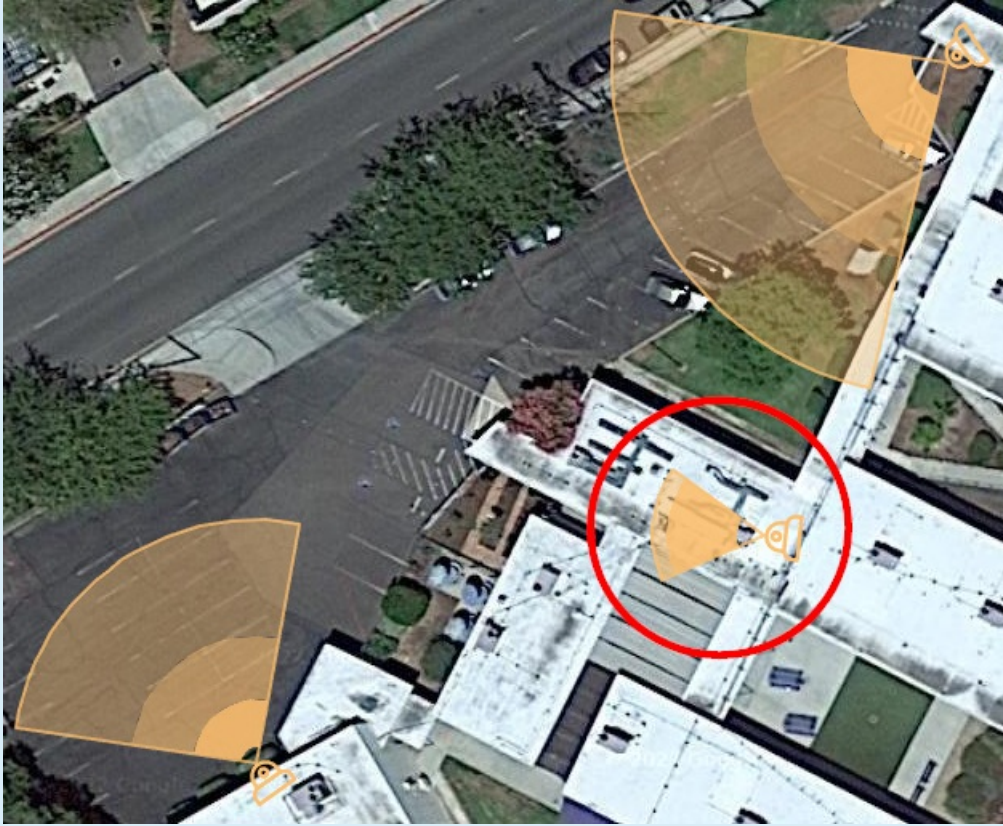
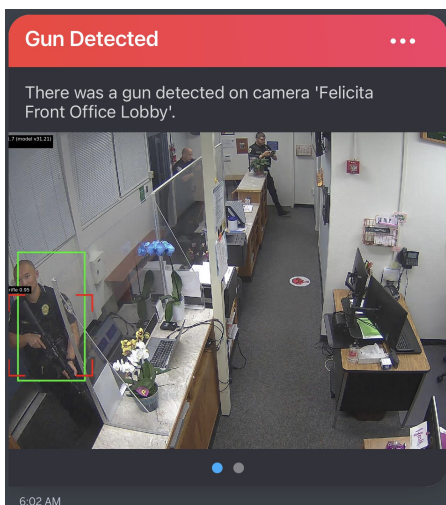
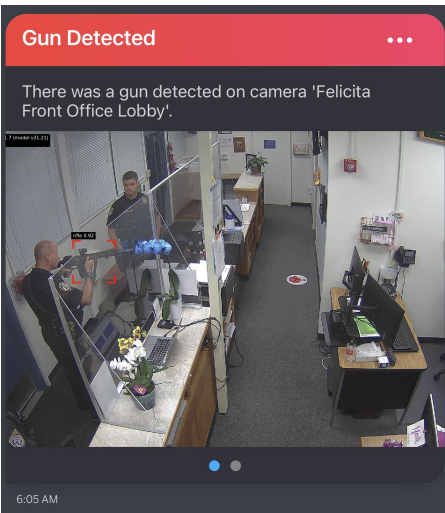
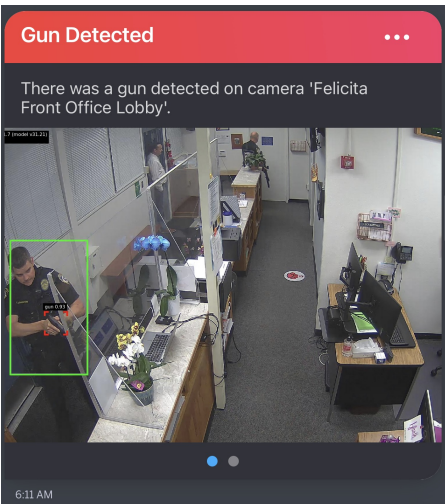
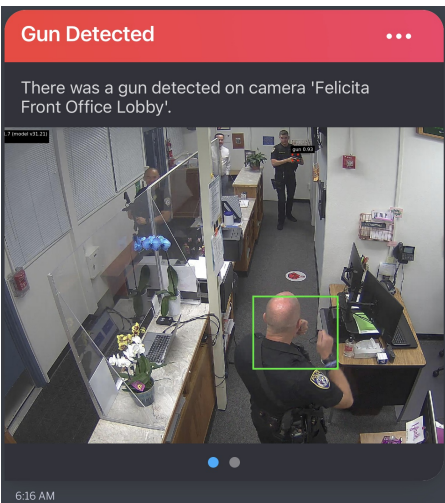
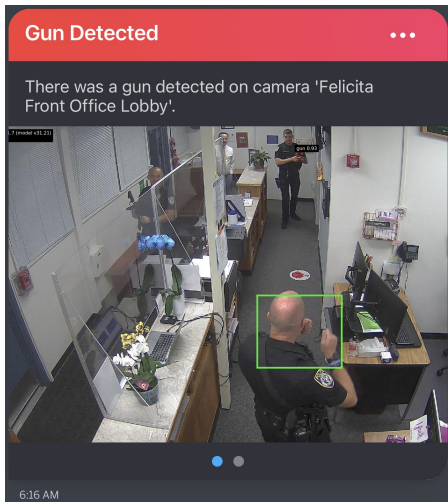
Felicita lobby cam

None of the detections occurred as the officers came in the public entrance (the far door from the camera view), so that's a camera mounting location issue, but in my opinion it also missed a large number of opportunities for detection--for instance, the second detection screenshot below shows the officer with the rifle in frame and very visible, but the detection is from the handgun in the foreground.

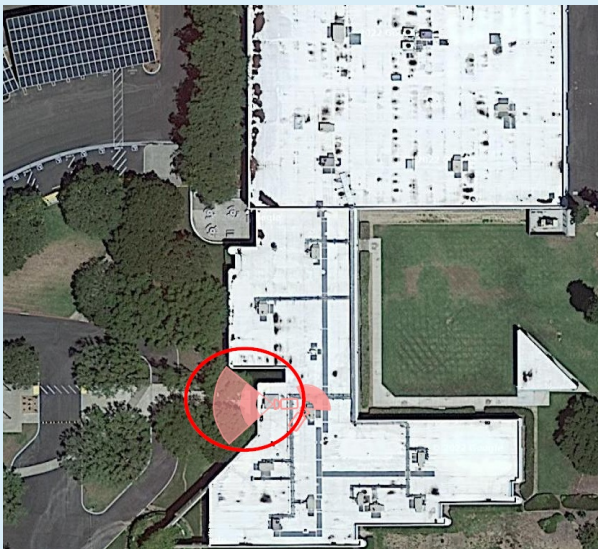
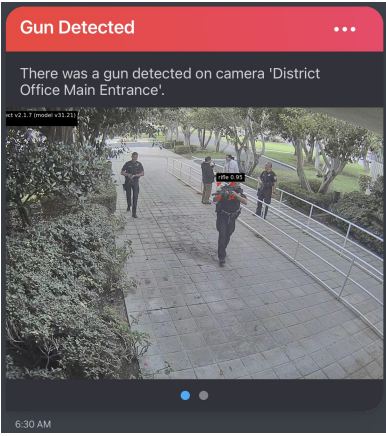
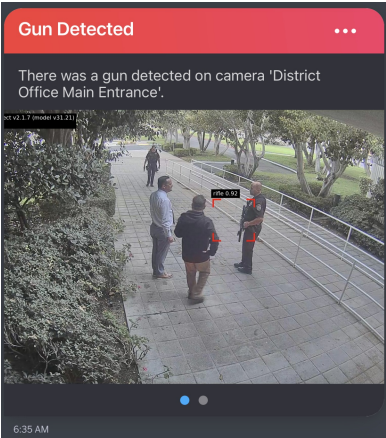
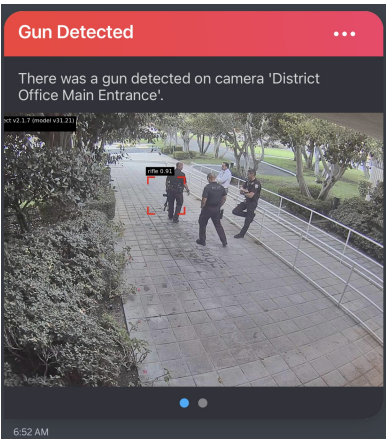
District Office entrance camera

There were 3 detections from this older Sony camera, but detection alerts came slowly and there were much fewer detections than expected given how many times the officers walked in and out of frame with weapons drawn.

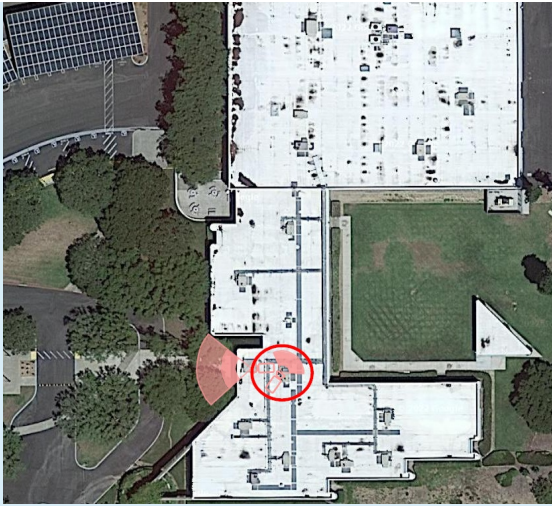
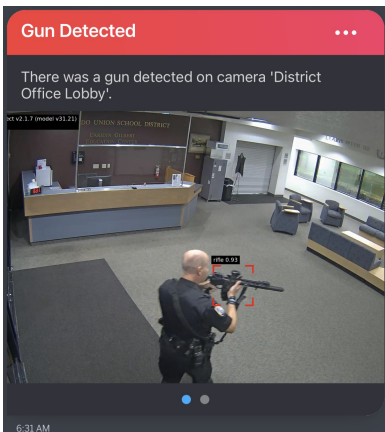
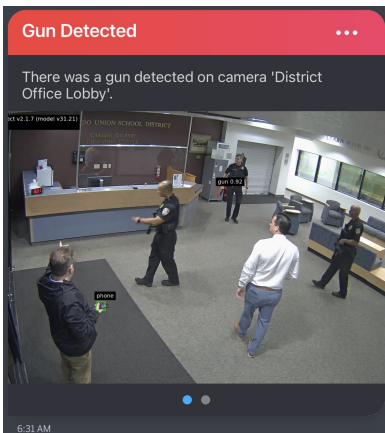
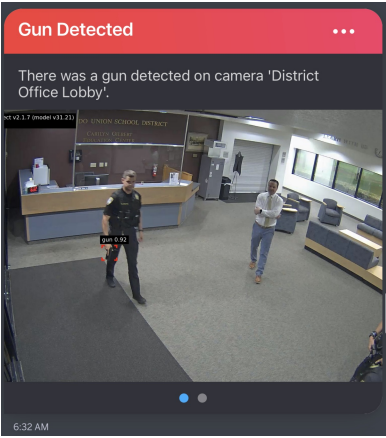
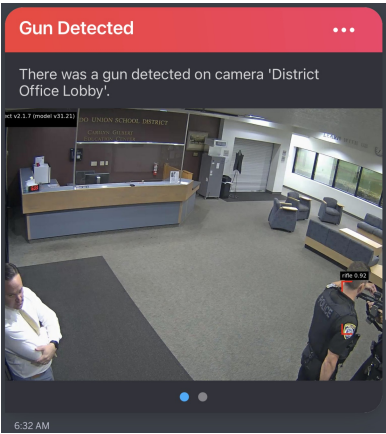
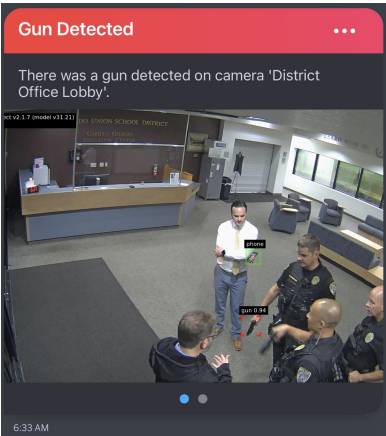
District Office lobby cam

This camera had 7 detections, but we would have expected many more from the amount of time spent in front of the camera with weapons displayed.

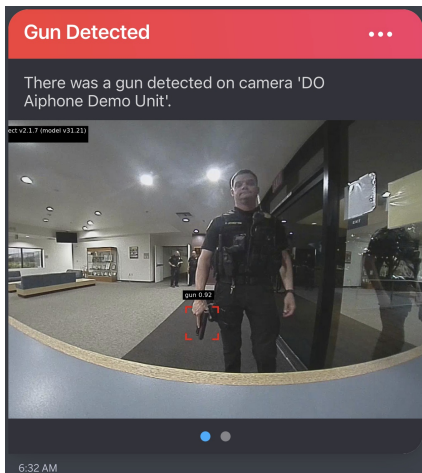
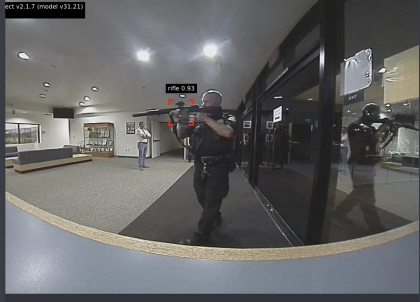
District Office Aiphone test unit (for site gates)

This was a test to see if this lower pixel unit that we plan to deploy to all sites' main entrance gates. There's no raw footage for this detection.

There was a gun detected on camera 'DO Aiphone Demo Unit'.
